HOTEL MONACO
HISTORIC CORNICE
REPAIR

The Hotel Monaco Historic Cornice Repair project was an approximately \$200,000 project completed expeditiously in three months to repair a seven foot long portion of the decorative marble lower cornice which fell from the building suddenly on July 15, 2010. This historic landmark was formerly the original US General Post Office and is located in Washington, DC. The project involved a series of initial investigations, specialized testing of the historic marble and mortar, installation of new hand-carved replacement cornice elements utilizing marble from the original quarry, and other miscellaneous repairs to the marble façade in an effort to arrest detrimental water infiltration. Water migration through cracks in the marble throughout many freeze/thaw cycles was determined to have caused the failure; atmospheric staining was present on over eighty percent of the length of the break. Two horizontal slabs of marble make up the cornice; the lower cornice (10" thick) consists of decorative dentils and rosettes; the upper cornice (8" thick) features a decorative profile. Both

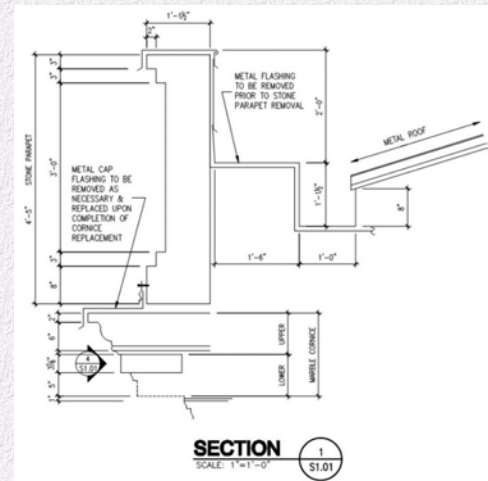
Cornice and parapet wall assembly profile.

The cornice where the failure and subsequent repair occurred is located at the roof level toward the South end of the East (7th Street) elevation. There are two horizontal slabs that form the cornice: the upper part of the cornice is eight inches thick and features a decorative profile; the lower part of the cornice is ten inches thick and features dentils and rosette medallions attached to the underside of the cornice between dentils. A large capstone, which forms the parapet wall, sits atop the cornice, acting as a counterweight. The cornice projects approximately two feet from the face of the parapet capstone. Both the parapet and cornice ledge are flashed with copper sheet flashing.

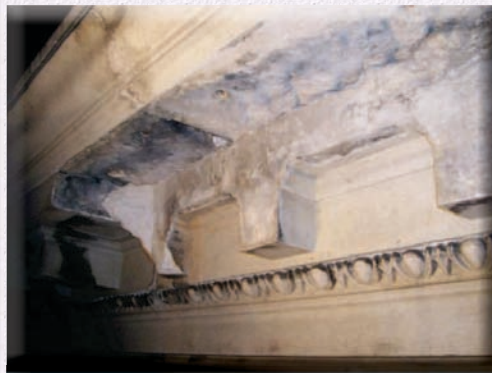
Lower cornice immediately after failure; note water staining along majority of break, as well as along the vertical head joint in the upper cornice above.

On July 15, 2010, an approximately 6'-8" long section of the lower cornice containing five dentils fell suddenly. The marble failed approximately eleven inches back from the face; the remaining surrounding marble was determined to be in sound condition. Initial investigations revealed that the failure was due to water infiltration through cracked and

open mortar joints in the parapet capstone and cornice over multiple freeze/thaw cycles, which caused an interior crack to develop. Atmospheric staining was present along eighty percent of the length of the break, suggesting that the crack had been there for some time prior to the failure. As the crack expanded and separated,

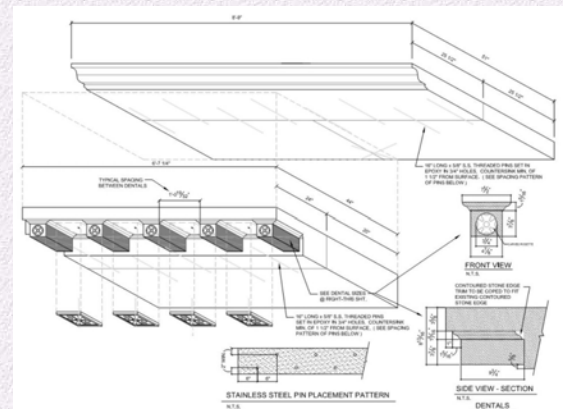
Isometric repair details for upper and lower cornice where failure occurred.

Since there was virtually no lead time for the locally available salvaged Beaver Dam marble, fabrication of the replacement pieces began almost immediately; shop drawings and supporting engineering calculations were generated and approved expeditiously. Slabs of the salvaged marble were not available in sizes large enough to fabricate the full fifty-one inch depth of the upper cornice slab, nor the forty-four inch depth of the lower cornice slab; therefore, replacement cornice pieces were fabricated as two separate pieces, and were doweled and epoxied

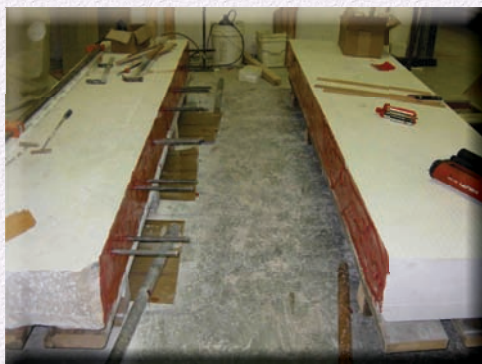
Epoxy and stainless steel dowels in place for 2-piece connection of upper cornice replacement.

ledge. Stainless steel dowels were embedded and grouted in epoxy eight inches on each side in a staggered configuration, approximately nine inches on-center. Pull tests were performed by the fabricator, confirming that the dowels have the capacity to transfer the design loads through the abutted pieces of marble. A similar procedure ensued for fabrication of a replacement piece for the reentrant corner of the lower cornice; three pieces were doweled and epoxied together to form the entire replacement piece.

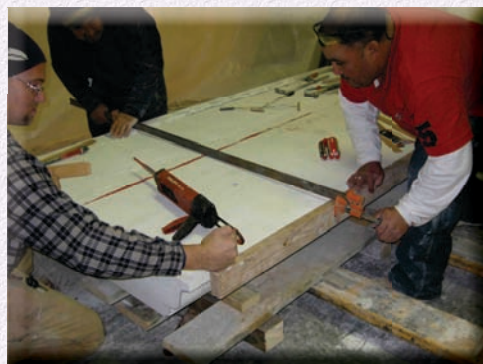
Fabrication crew secures clamps to hold front and rear pieces of upper cornice replacement stone together until epoxy cures. Crew also checks for positive drainage slope.

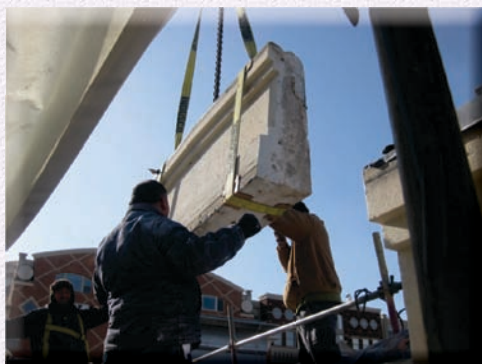
Parapet capstone hoisted to access cornice replacement area.

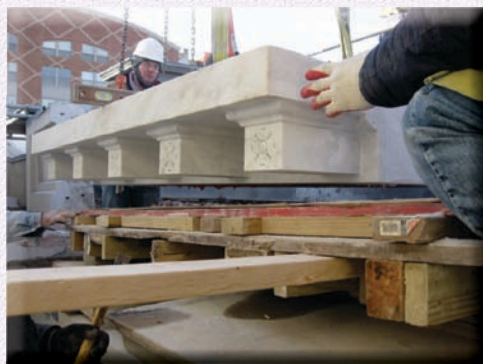
Lower cornice replacement piece hoisted; note attention to detail in carved dentils.

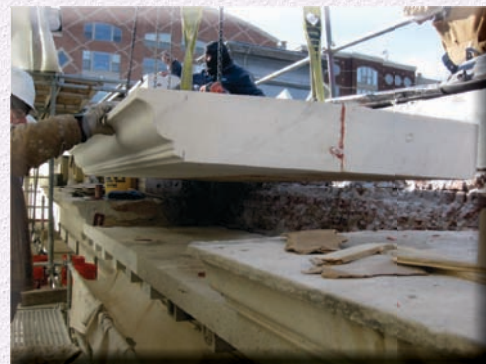
Upper cornice replacement piece lowered into position atop already installed lower cornice replacement piece.

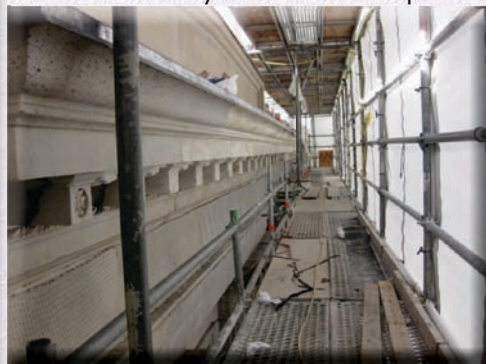
Completed upper and lower cornice replacement where failure occurred. Flashing re-installation underway.

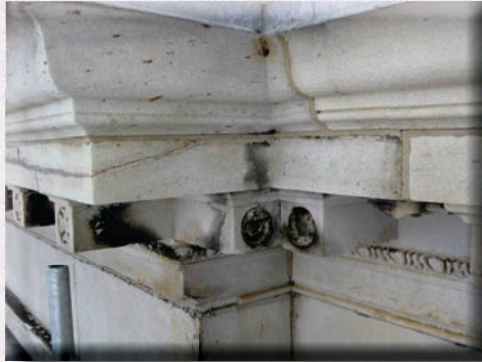
Cracked reentrant corner of the lower cornice prior to replacement.

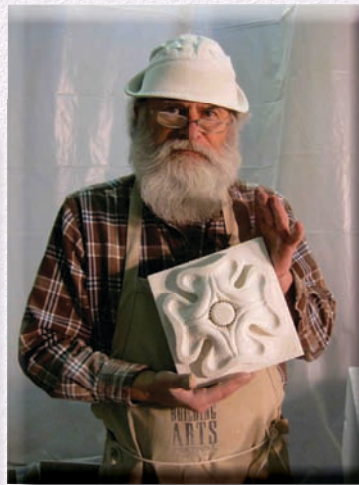
The stone carver displaying one of the replacement rosette medallions that he hand-carved to match the existing.

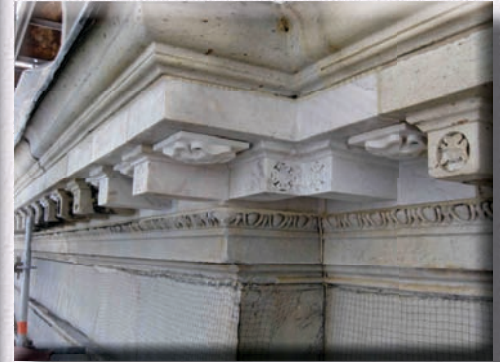
Reentrant corner lower cornice replaced; replacement rosette medallions anchored with stainless steel pins and epoxy on soffit between dentils.

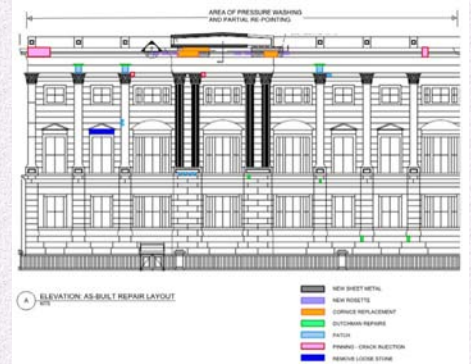
Overall as-built map of repairs including cornice replacements.

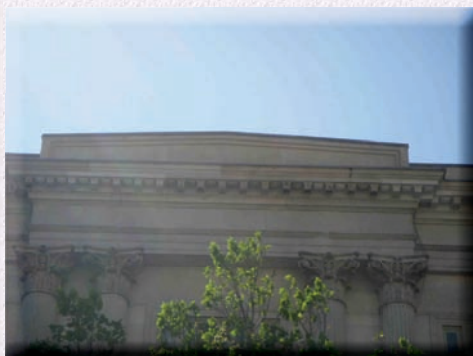
Overall completed historic cornice repairs.
