BREATHING LIFE BACK INTO AGING INDUSTRIAL INFRASTRUCTURE

Repair Case History

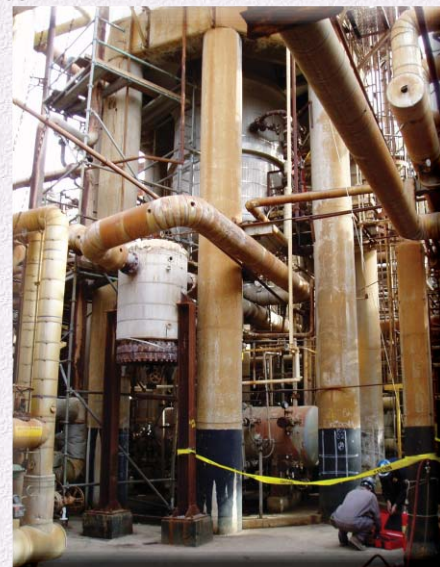
**View of Vacuum Tower Support
Structure prior to repair in advanced
state-of-deterioration.**

A massive 50 year-old conventionally reinforced concrete structure supporting a critical Crude Unit Vacuum Tower within a Petroleum Refinery along the Gulf Coast in the Southwest USA, was significantly distressed and perceived by plant reliability personnel to have reduced operating serviceability; leaving the Owner/Operator in a quandary as to whether they should repair or replace the structural support system. Supporting well over 600,000 lbs of process equipment weight while in service, the eight (8) Column support structure was experiencing on-going embedded metal corrosion activity resulting in extensively deteriorated support Columns and Beams. Significant cross-sectional losses in reinforced concrete members were noted, as well as falling concrete hazards. The Owner/Operator had to barricade the areas surrounding the structure from plant personnel as a hazard mitigation measure. Recognizing the need to address the conditions of this critical support structure, the Owner/Operator contracted to have a comprehensive Condition Assessment and Structural Analysis be performed on the subject structure. The evaluative effort, it was hoped, would identify "Root-Cause" deterioration mechanisms as well as provide recommendations that would restore the support structure to as-designed serviceability.

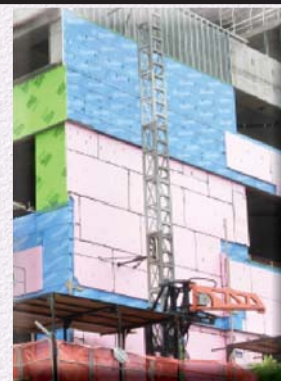
**Typical steel stud brick veneer insulated cavity
wall construction**

Cost effective connections to the steel stud have limited options. Preferably, self-drilling/self-tapping screws are ideal. The screw incorporates a drilling tip designed to provide a pilot hole for optimum thread engagement to the steel. Sheet metal screws which are self tapping but require a pre-drilled pilot hole are acceptable, however the installation method requiring two drilling operations usually limits the appeal from a cost and efficiency point of view. The performance of the self tapping screw is also dependent on the pilot hole drill size used. A 300 series stainless steel sheet metal screw or self tapping screw may be more cost effective then using bi-metal self drilling tips on a 300 series stainless self drilling screw and possibly worth evaluating.

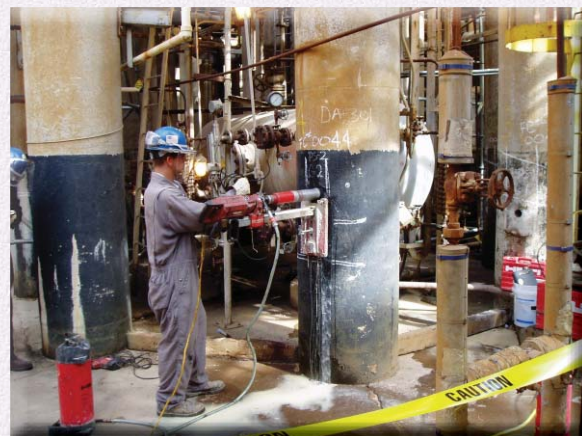
Concrete Core Sampling During the Condition Assessment Phase of the Project.

During the Condition Assessment, a series of Non-Destructive and Semi-Destructive Testing (NDT & SDT) protocols were employed to determine both the chemical and physical characteristics of the concrete materials-of-construction. Existing concrete materials were determined to be carbonated (cement paste matrix at a pH <9.8), extensively delaminated (internal separations within the concrete caused by the expansion of corroding embedded reinforcing steel bars) and thoroughly contaminated with elevated levels of chloride (2 to 5 times the threshold value established by the American Concrete Institute). Although poor chemically, once the delaminated concrete was removed, the physical characteristics of the concrete were good with corrected existing compressive strength values ranging 4,500 to 7,500 PSI on a structure originally specified to be a minimum of 3,000 PSI.

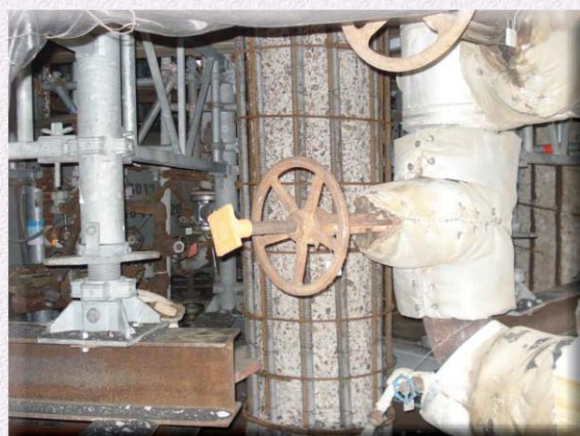
Exposed Steel reinforcement, with new augmented bars and Column ties. Note Vessel Support Shoring next to Column and Operating Jacketed Hot Process Piping/Valves.

With the delaminated/unsound concrete removed, the exposed corroded reinforcing steel was cleaned and new reinforcing steel installed to augment existing reinforcement containing significant cross-sectional losses. The exposed reinforcement was then tested for continuity and electrically connected where discontinuous. Then, the two-piece Lifejacket® assembly was placed overtop of the prepared surfaces, strapped into place and the annulus cavity grouted with prebagged cementitious grout, mixed, batched

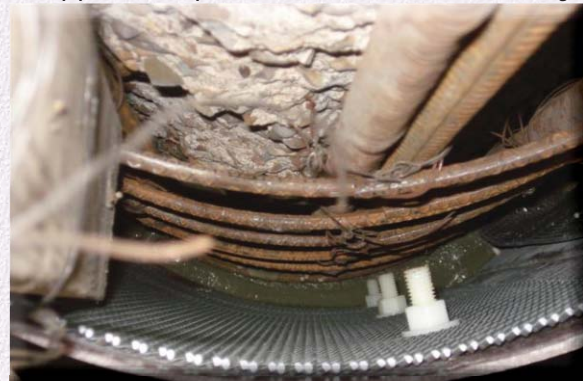
View of the Annulus Cavity during Cementitious Grouting Operations. Easily seen are the non-metallic hold-off bolts, Zinc-anode Mesh, Fiberglass Form and grout placement rising from base of form.

Note the form follows the original circular contour of the Column structural member, although approximately 4" larger in diameter.

and placed on-site. The installed cementitious grout not only provides a structural composite repair to the existing substrate, but also encapsulates and promotes electrical connectivity between the embedded reinforcing steel and the Zinc-anode attached to the external Fiberglass Form.

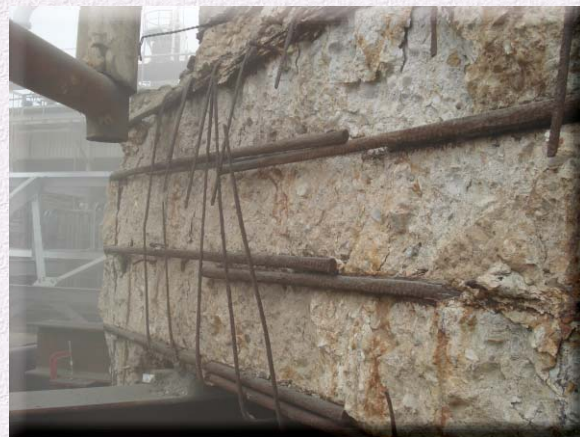
Delaminated "cover" concrete removed from Support Beam members exposing corroded reinforcing steel bars and relic indicators of rebar beam stirrups.

The repair process began with the removal of delaminated (i.e., partially detached/unsound) concrete from specific support Columns - essentially repairing opposing Support Column Legs, two at a time in phases in a manner similar to tightening lugs bolts when changing a car tire. The repair required that the two phased Columns be completed prior to proceeding to the next set of opposing Support Column Legs with the repair of the elevated supporting Beams following a similar sequential repair format. Work took place even with all the process equipment supported as an additional safety precaution.

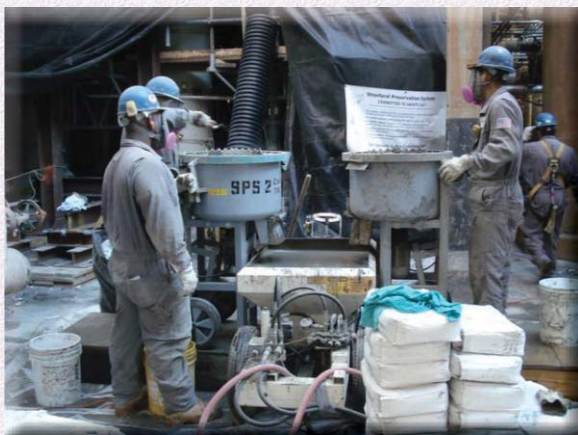
On-site Cementitious Grout Batching Operation adjacent to the area of Work using pneumatic mixers and hydraulic pump conveyance.

The added value of the prebagged cementitious grout materials was rapid strength gain which allowed relatively quick cycling between phased repair operations and the flexibility to adjust the construction schedule should the Owner/Operator require modifications due to process demands.

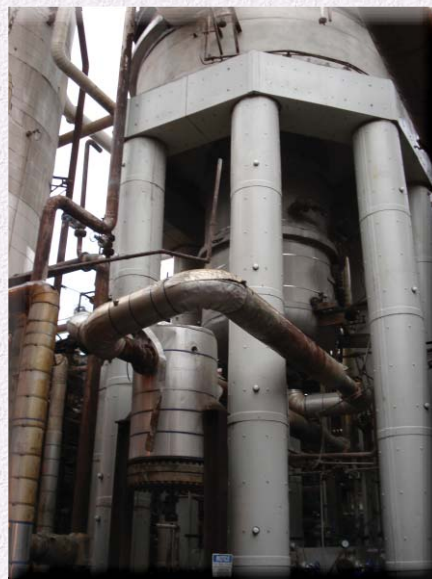
View of Vacuum Tower after completing phased Column, Beam, and Vessel Skirt Repairs and subsequent to the removal of Structural Support Shoring.
