**Structural Damage
Resulting from the
Earthquake of 2011**

Structural Damage Resulting from the Earthquake of 2011

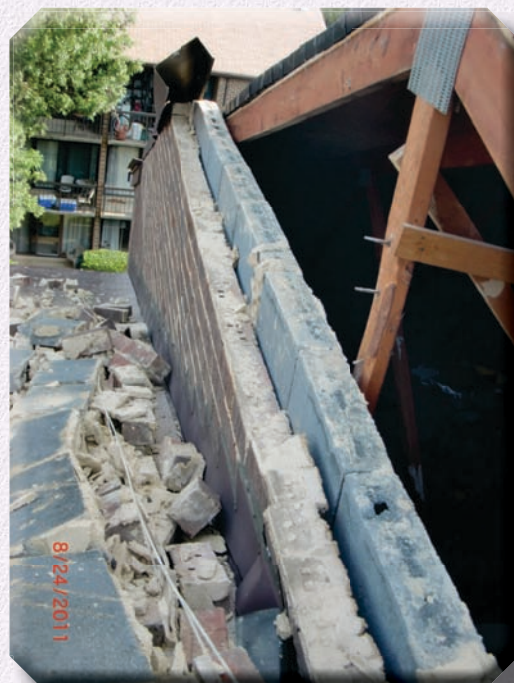
Photo 1 - Brick and CMU gable end wall toppled over due to lack of ties to the structure.

The most severe damage was at masonry gable walls between buildings. Large sections of masonry dislodged from the pitched roof trusses and either crashed through the roof or stood precariously out-of-plumb (by as much as four inches). The masonry wall did not have any ties back to the structure above the adjoining roofline; thus, the concrete masonry unit (CMU) backup wall and brick facing comprised a cantilever sticking up (unsupported) about seven feet. These buildings had weathered many storms over the years, but no event was strong enough to reveal this defect that existed from original construction.

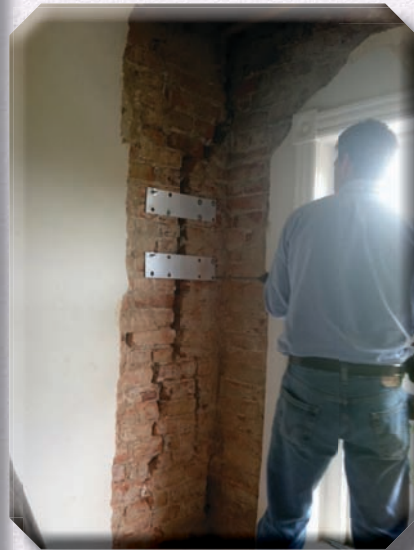
A hundred year old, three-story row house structure, with thick brick walls, had large sections of the front façade rotated out of plumb by nearly three inches. The greatest displacement was where abutting and reinforcing masonry walls had become disconnected from the façade. Those cracks were not new, but they widened significantly after being shaken. The cracks had been filled with spackling over the years, but were never properly repaired.

Photo 3 – Temporary supports applied over the cracked masonry to stabilize the structure.

See Photo 3 (left). Consequently, large portions of the façade need to be removed and reconstructed.

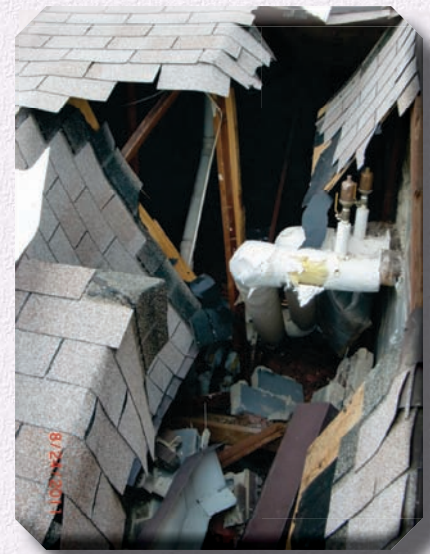
Photo 2 – Some of the masonry crashed through the wood framed roof and damaged the roof trusses.

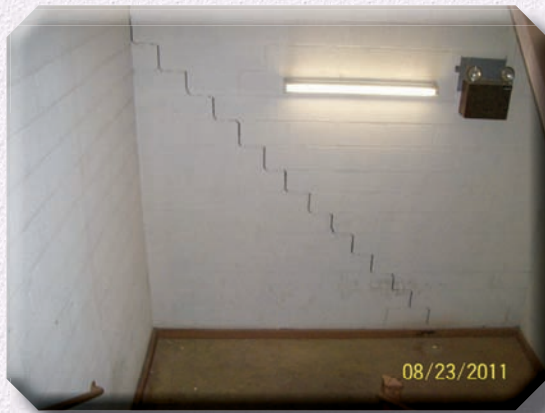
Consider a low-rise condominium complex, which experienced cracking and displacement at the connection between the masonry columns of a porch to the end wall above. Prior to the earthquake, minor staircase cracking was observed. After the earthquake, the cracks were much wider and the masonry columns had pulled away from the end wall. See Photo 4 (page 7)

ETC determined that there were no footings below the porch columns, which jeopardized the structural integrity of the building from the day it was built. The minor cracking observed prior to the earthquake should have been a telltale sign that there was something wrong. If this problem had been investigated further and subsequently repaired, major damage could have been averted and the structure could have been salvaged. Unfortunately the cost of repairs was so high; the Owners opted instead to remove the porch.

Photo 4 – Wide cracks in this masonry porch structure due to a lack of a proper foundation resulted in demolition of the entire porch.
