## Mount Carmel Municipal Authority Wastewater Treatment Plant SBR Tank#1 Repair

## 2014 ICRI Baltimore Washington Chapter Outstanding Repair Project Winner

**Project Name:** Mount Carmel Municipal Authority  
Wastewater Treatment Plant  
SBR Tank#1 Repair

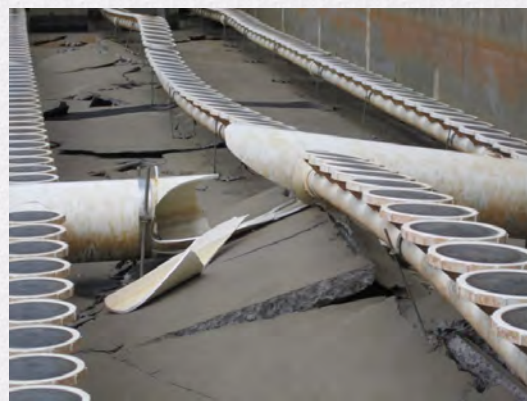
In September, 2011 the devastation of Hurricane Sandy took its toll on the newly constructed SBR tanks. In addition to sewage overflows, flood waters from Sandy severely damaged the treatment plant. The treatment plant is bordered by the Shamokin Creek on the southeast side with the creek's floodplain positioned beneath the largest portion of the site. Furthermore, published geologic information maps indicate that the bedrock underlying the site is comprised of coal beds. Several of the coal beds are minable and together they make up the Western Anthracite Field. For years these coal beds have been extensively mined by deep methods throughout the Mount Carmel area.

Flood waters from Sandy's torrential downpours overflowed Shamokin Creek into the floodplain forcing the flood waters into an undetected abandoned deep mine located in close proximity to SBR Tank #1. The hydrostatic pressure exerted by the flooding mine forced the mat foundation of SBR Tank #1 to buckle resulting in a chain reaction when the forces were released by the post-tension system embedded in the slab. Overall resulting damage included slab buckling, foundation movements, foundation wall displacement, walkway displacement, and column structural damage.

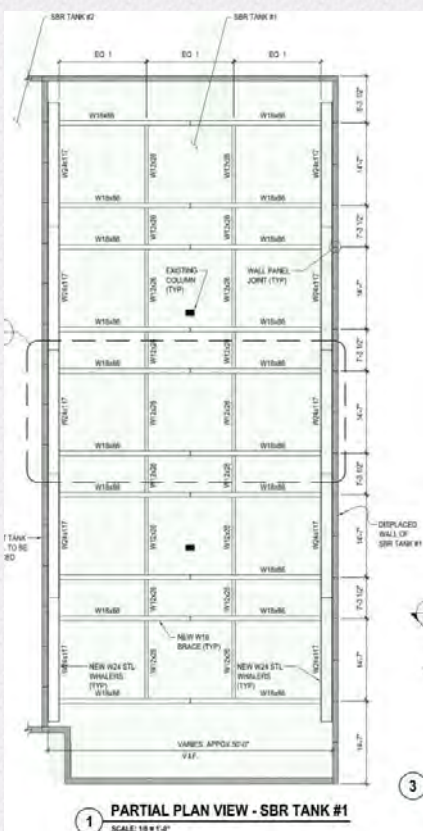
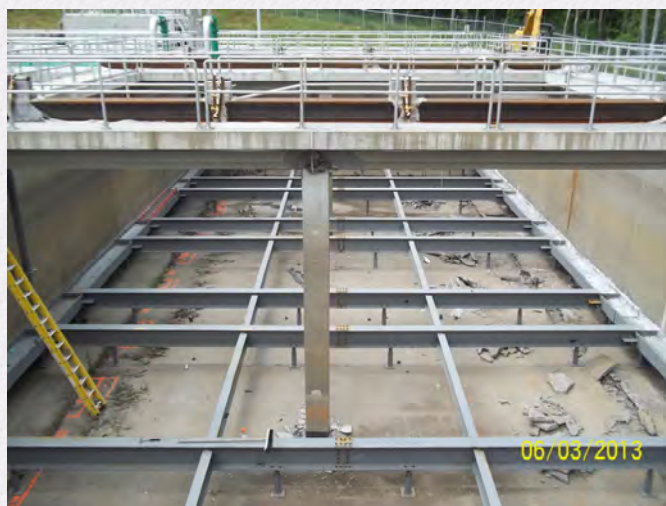
Immediately upon discovery of the structural failure an extensive shoring system was designed and installed to stabilize the structure while the adjacent tanks, SBR #2 and SBR #3, stayed in operation. Temporary shoring consisted of the installation of a grid of wide flange beams to laterally brace the structure and prevent any further movement.

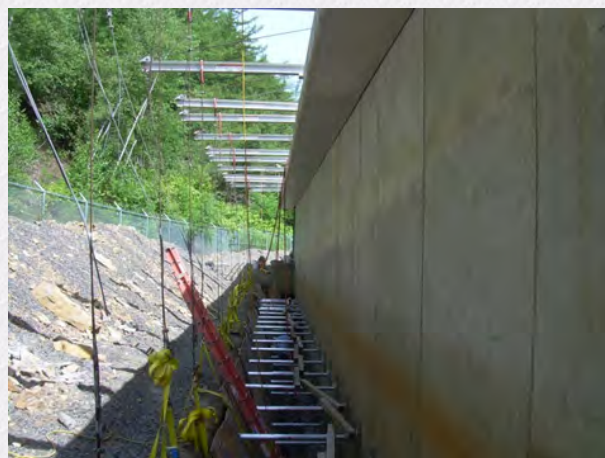
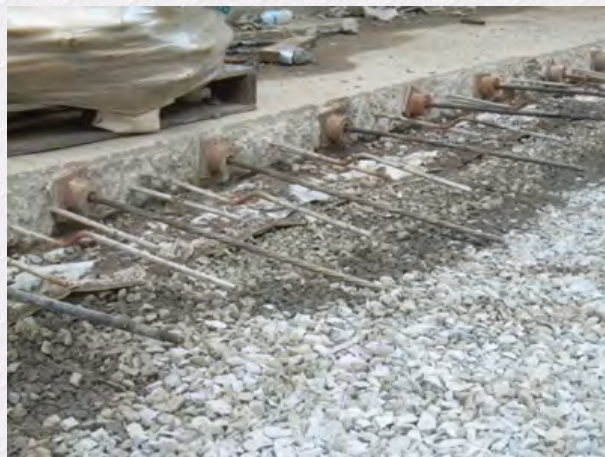
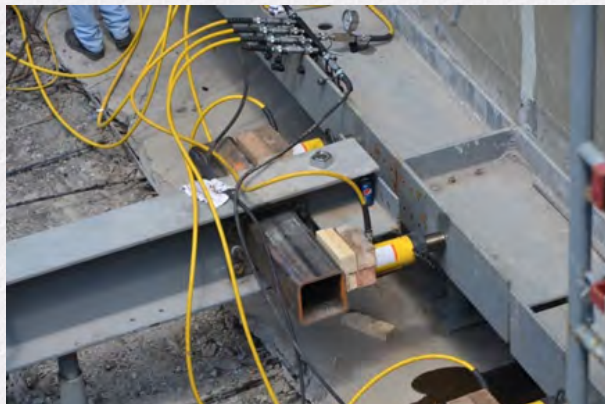
7. Once lock-offs were installed, crews de-tensioned the tendons in both direction to allow demolition of foundation slab.
8. Install additional steel supports and hydraulically jack north foundation wall to re-align and plumb. Wall was bowed 4" into the tank at the center of the wall base. Remove temporary wide flange bracing.

9. Demolish and remove the entire foundation slab in SBR #1 tank including existing diffusers.
10. Compact subgrade and add fill as required.
11. Install new reinforcing steel and post-tension tendons by splicing to the existing de-tensioned tendons.

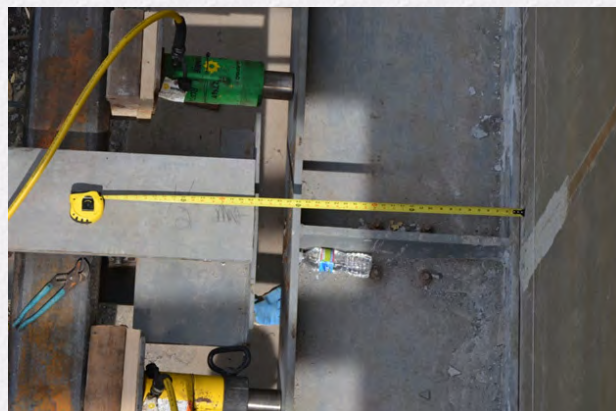
Heavy structural steel bracing was installed to prevent further displacement of the tank wall and consequential damage that could render the wall "un-repairable". The shoring was constructed of vertical W18x86 compression struts spanning the width of the tank and horizontal W24x117# whalers that transferred the load from the "intact" interior wall to the "displaced" exterior wall. This temporary shoring structure was utilized to return the displaced wall and footing to its original position as follows:

- Structural tube steel "jacking brackets" were installed on both sides of each compression strut, approximately 6' from the displaced wall.
- 50 ton hydraulic jacks were installed between the "jacking brackets" and the W24 whalers.
- The w24 whaler was unbolted from the compression strut.
- A hydraulic pump and manifold system was utilized to provide evenly distributed forces, to return the wall and foundation to the original plumb position.

The extensive temporary shoring was then removed from the tank so that the post tensioned slab could be reconstructed and re-tensioned.
