THE AGGREGATE

THE NEWSLETTER OF THE BALTIMORE WASHINGTON DC CHAPTER OF ICRI

THE TEMPLETON OF ALEXANDRIA CONDOMINIUM PROJECT

By **D. Kipp Gaynor, PE**
Structural Rehabilitation
Group

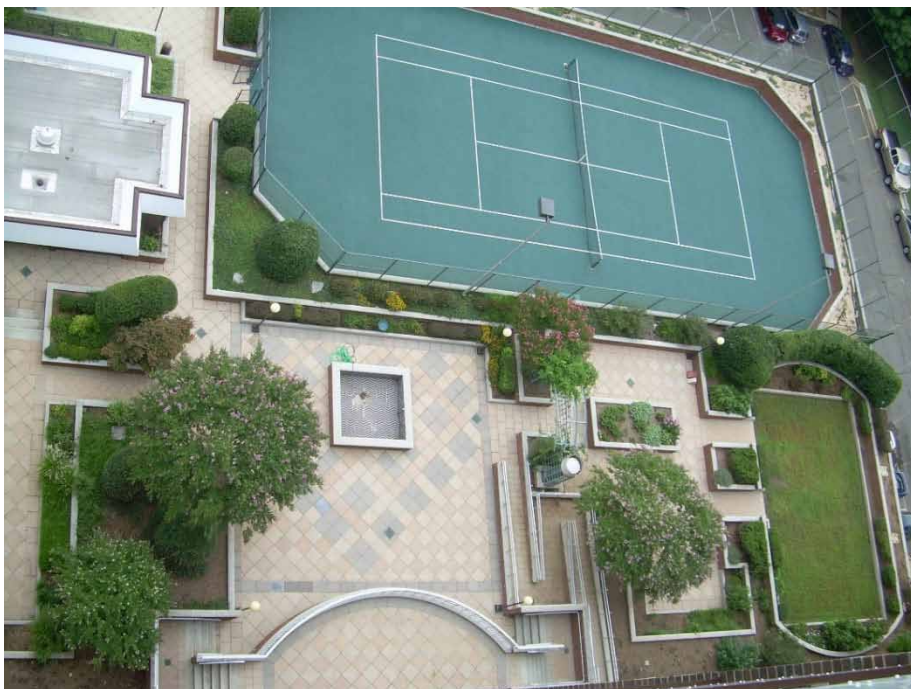
Figure 1- Bird's eye view of the plaza (consisting planters, pavers, soil and hardscaping).

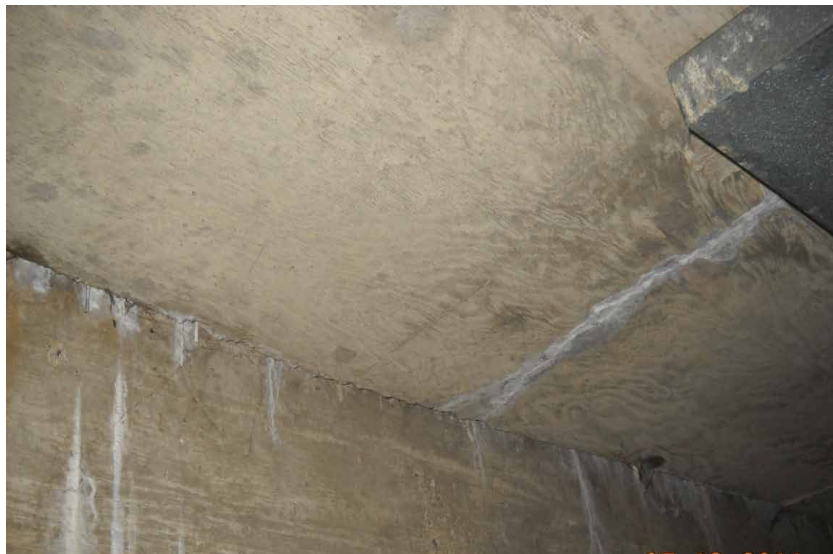
Figure 2- Cracking and water intrusion through the slab as well as slab-to-wall transition.

- The soffit of the post-tension plaza slab exhibited numerous areas of distress in the form of cracking and water leakage. Cracking along with calcium carbonate accumulations including stalactites indicated that the plaza water intrusion had been on-going for an extended period of time.

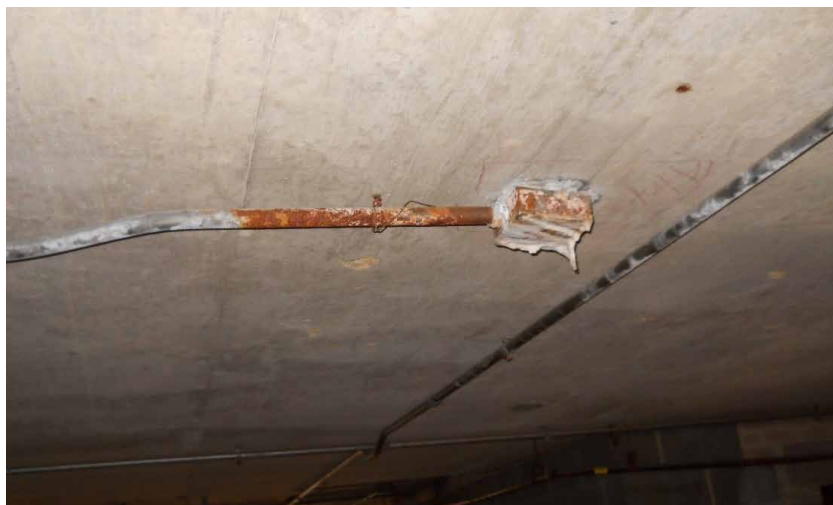
Figure 3- Corrosion of the surface mounted and embedded electrical conduits and junction boxes were visible at the underside of the concrete slab.

- Corrosion of embedded steel reinforcing and electrical conduits as well as surface mounted junction boxes, and leakage around drainage pipe penetrations.

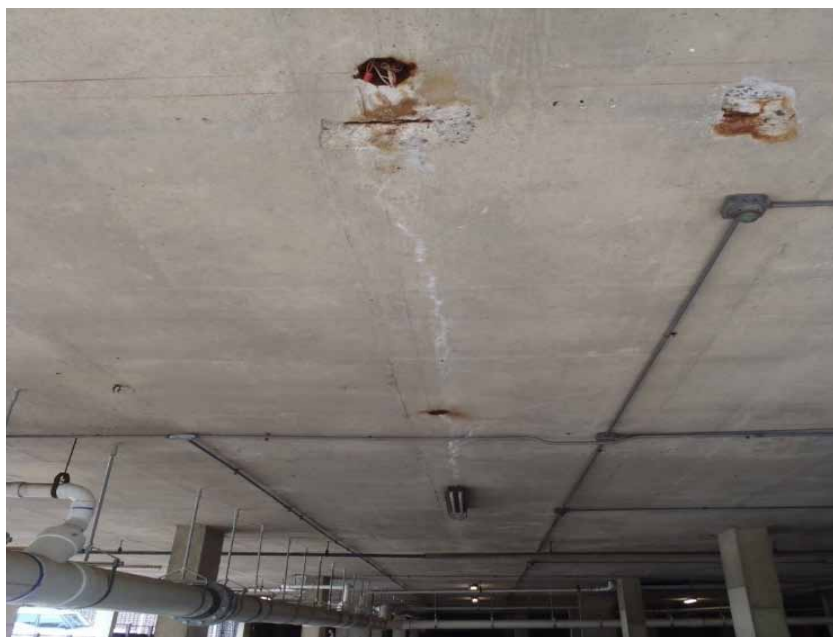
Figure 4- Cracking on the surface of the concrete slab aligned with the electrical conduits at mid-span.

- Several cracks were observed in the column strips while other cracks aligned with embedded electrical conduits.

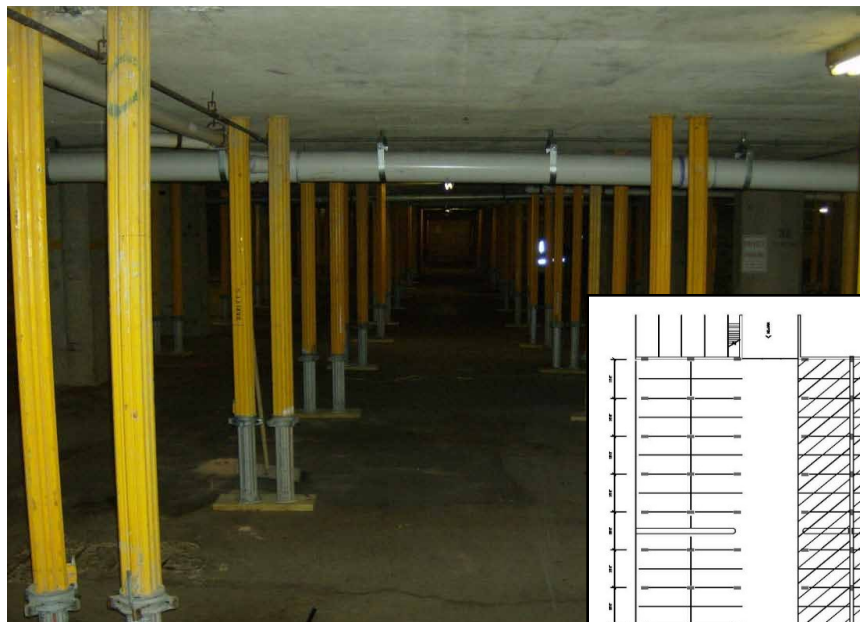
Figure 5- Shoring for plaza during the emergency load reduction phase.

The client was immediately notified that the plaza as well as all of the covered parking area needed to be closed to both vehicular as well as pedestrian access in the regions where excessive loading existed. The vehicular parking was closed under the plaza deck below the greenscaped and landscaped areas. An emergency shoring solicitation was undertaken and a Contractor was retained. Shoring was installed and a zero live load plaza restriction was mandated for the area, so the parking bays below the tennis court area could be reopened. The plaza level remained closed to pedestrians, however, pedestrian access at the garage level was restored in a defined walkway to accommodate building core access below the shored work area.

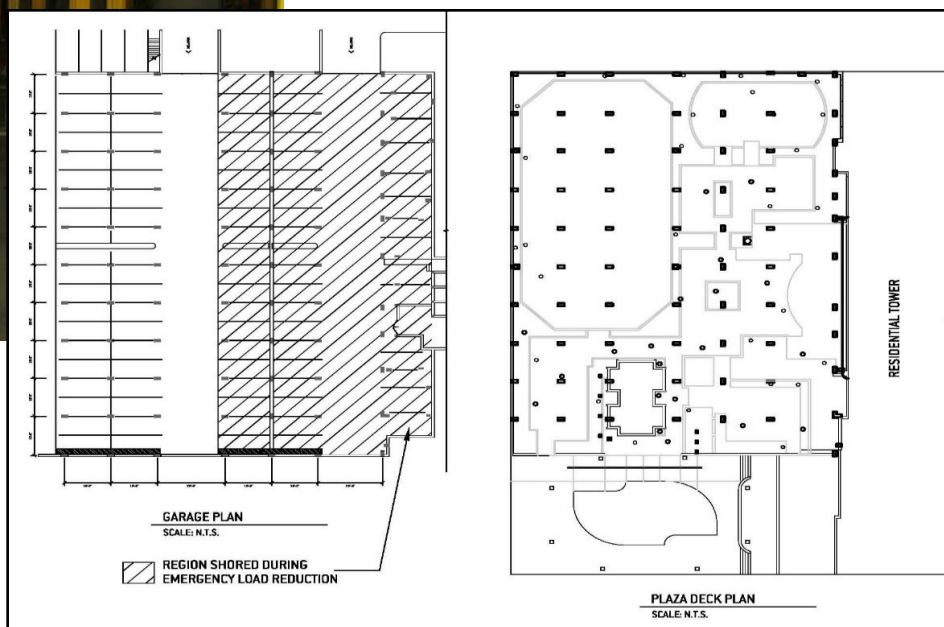
Figure 6- Plaza and garage plan (hatched area shows the region requiring shoring during emergency load reduction).

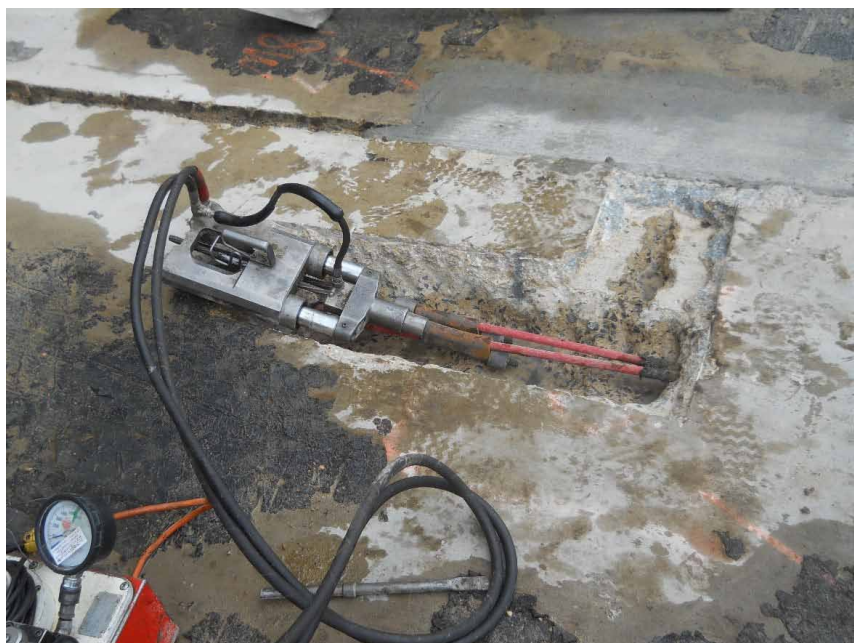
Figure 7- Stressing of the post-tensioning tendons after replacement.

In total, 69 tendons were repaired (spliced) or completely replaced as part of the Contractor's work plus the installation of the external reinforcing. The rehabilitated post-tensioned and externally reinforced slab was designed to safely support a live load of 100 psf along with a SDL of 100 psf.

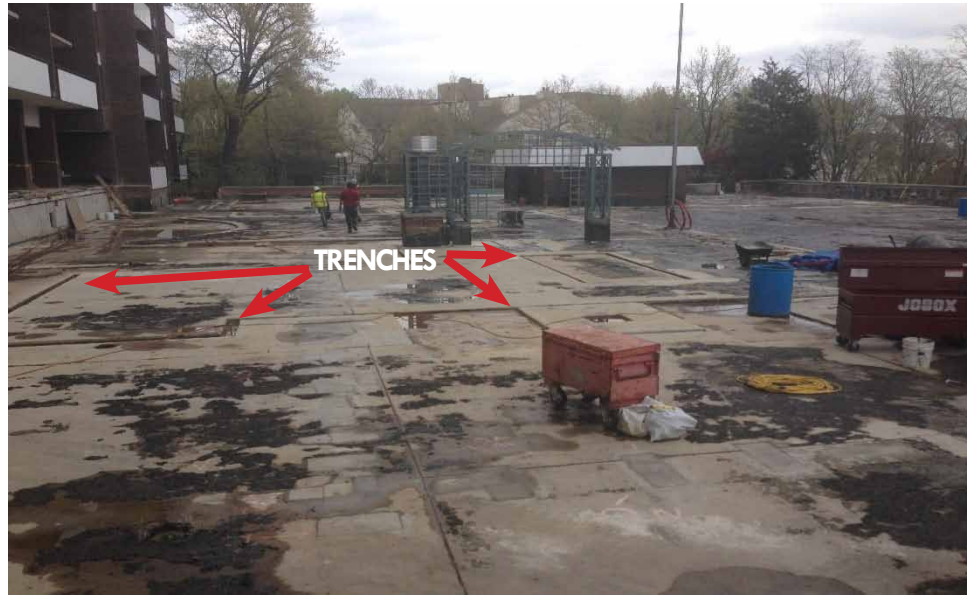
Figure 8- Plaza demolition revealed topping slabs that overlaid the structural deck.

When the emergency load reduction work was completed, it was revealed that the renovation performed in the 90's included the addition of concrete topping materials to enhance drainage. A network of troughs/trenches remained where the prior site walls existed. These troughs were problematic in detailing the waterproofing system and the topping slab/overlay represented additional dead load on a deck that was already overloaded and under designed. In evaluating the options to address the topping/deck profile issues, three (3) remedial options were considered as follows:

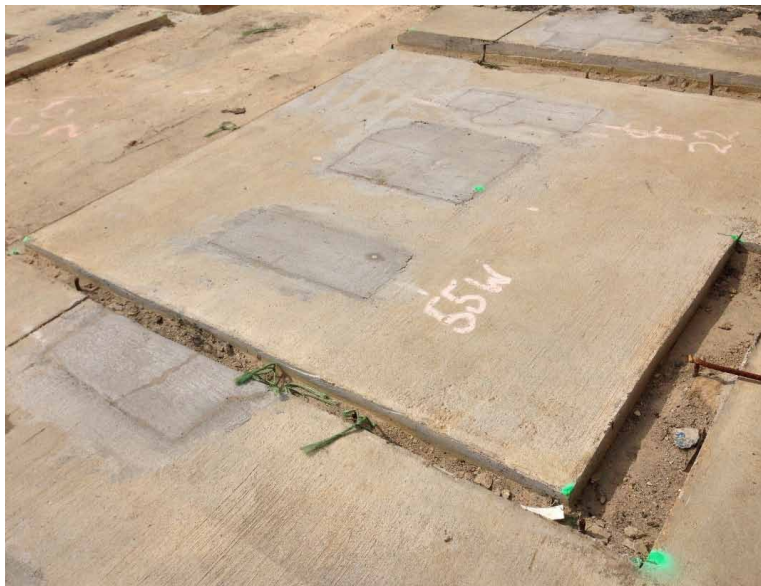
Figure 9- Pull off testing performed to evaluate the adhesion of the in-situ toppings.

Pull off testing work was performed to establish the adhesion of the toppings. The topping slab pull off tests revealed sufficient adhesion to confirm that the toppings were well bonded and could be considered to be acting compositely with the structural slab. These findings resulted in a significant cost savings to the Owner in reduced labor and disposal fees as well as substrate preparation related costs. The repurposing of the in-situ toppings not only saved the Owner rehabilitation demolition costs and time but also provided a green alternative by reducing the impact on our planet from the demolition and disposal related activities.

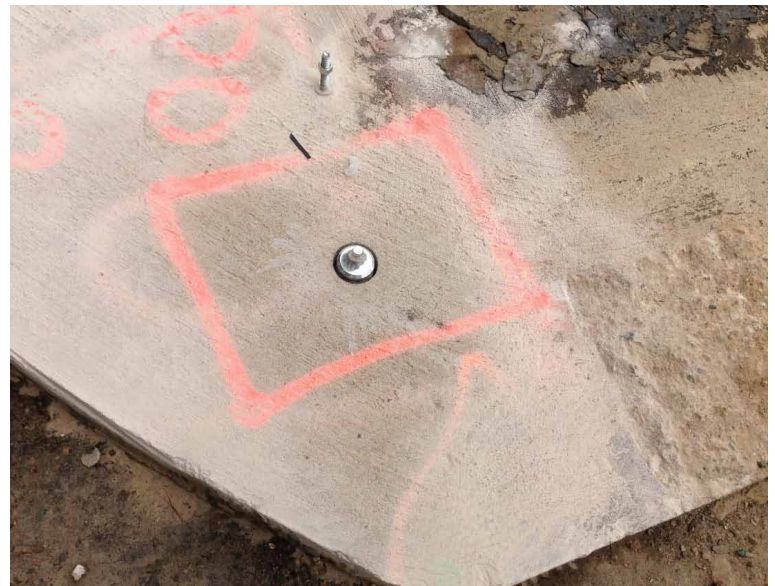
Figure 10- Toppings added dead load but also increased the decks load capacity by leveraging a greater "d" between CG and tendon centerline.

- Remove all the toppings down to the structural deck to reduce the SDL.
- Leave the existing topping in place and infill the trough/trench areas to facilitate simplification of the future waterproofing system and water management design. This would require that the future SDL be reduced by the weight of the as-built topping materials.
- Leave the existing topping in place and prove by testing and analysis that the toppings were acting compositely with the existing structural slab. If confirmed, this would result in a net increase in the plaza decks as-built live and dead load capacity by increasing the center of gravity (CG) of the slab.

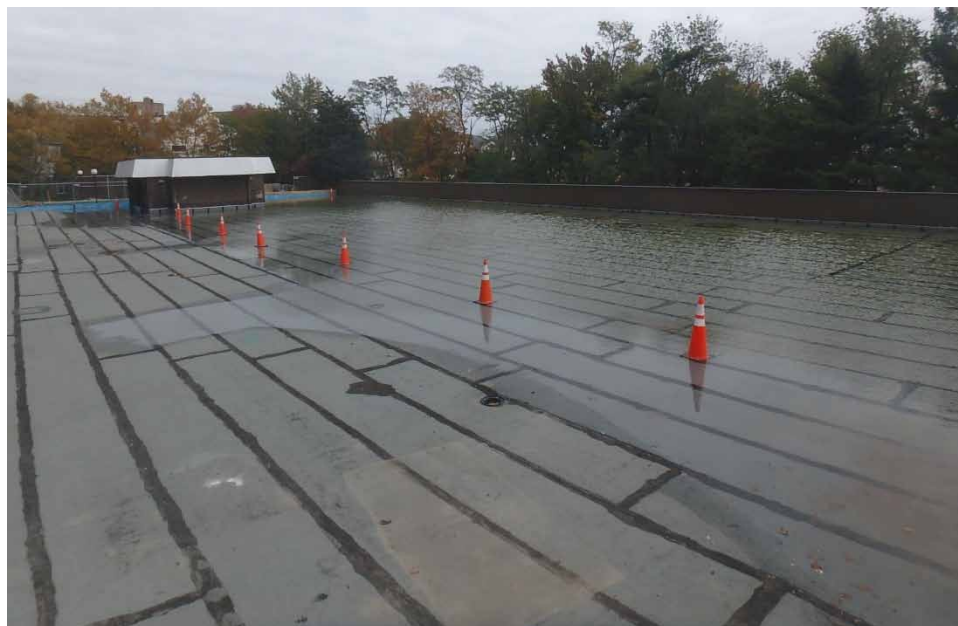
Figure 13- Down slope hydrostatic validation water test.
