# THE AGGREGATE

- PRESIDENT'S MESSAGE
- ANNUAL AWARDS BANQUET
- 2019 GOLF RECAP
- TECHNICAL ARTICLE: TERRA COTTA

THE NEWSLETTER OF  
THE BALTIMORE  
WASHINGTON DC  
CHAPTER OF ICRI

4TH QUARTER 2019

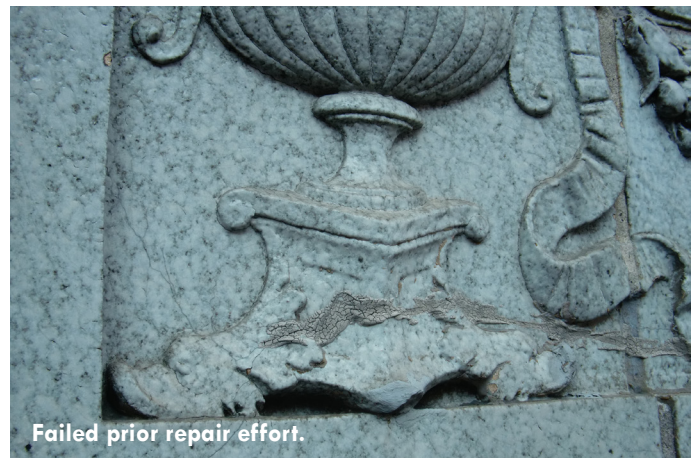
Exposed and free-standing terra cotta detailing, such as balusters and parapets, tends to deteriorate more quickly than other facade elements. Where anchoring is extensive and complex, deterioration and failure likewise tend to be more pronounced. Deterioration to terra cotta used as load-bearing masonry tends to be less severe, owing to its simple or limited anchoring system, which presents fewer opportunities for corrosion-induced cracking and failure.

For most architectural terra cotta, deterioration may be traced to some combination of four basic factors: moisture infiltration, the resultant corrosion of embedded steel, structural and thermal movement, and the ill effects of improper repairs.

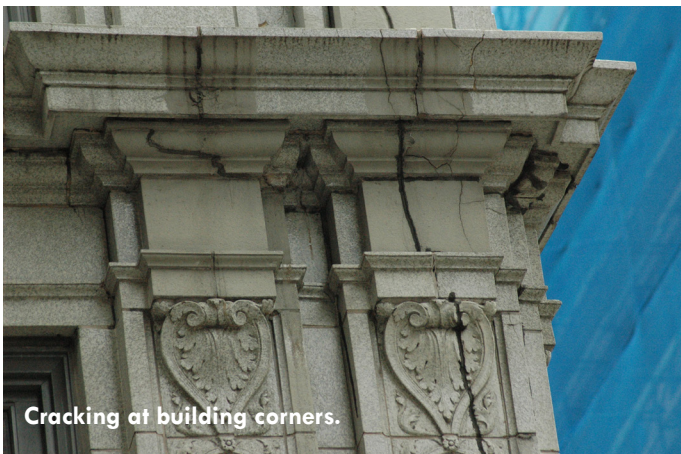
What makes embedded steel corrosion challenging to treat is that it tends to be difficult to diagnose unless it is severe. By the time symptoms are visible at the surface, corrosion is likely already advanced. Initial outward signs of metal anchoring deterioration might include staining and spalling. Total anchoring failure can result in loose terra cotta units, which are in danger of falling from the building.

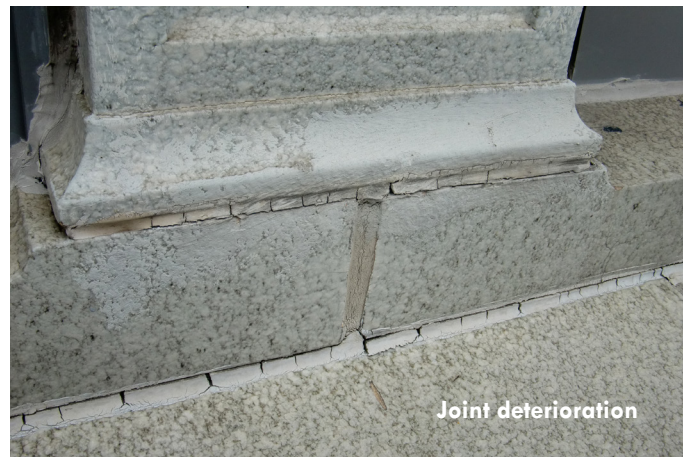
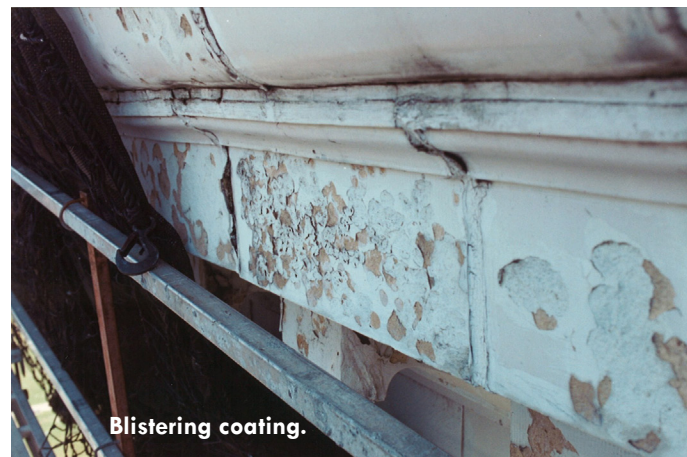
The misuse of sealant in place of mortar for joint repairs serves to trap water within the terra cotta, leading to corrosion of embedded steel and cracking and spalling of terra cotta. Unlike impervious sealants, mortar is porous and allows moisture to escape.

Alterations and additions to the building, such as signs, screens, marquees, and bird proofing, may also cause damage, where anchoring involves boring holes or cutting into the glazed terra cotta. When the appurtenances deteriorate or are removed, the holes remain, admitting water infiltration.

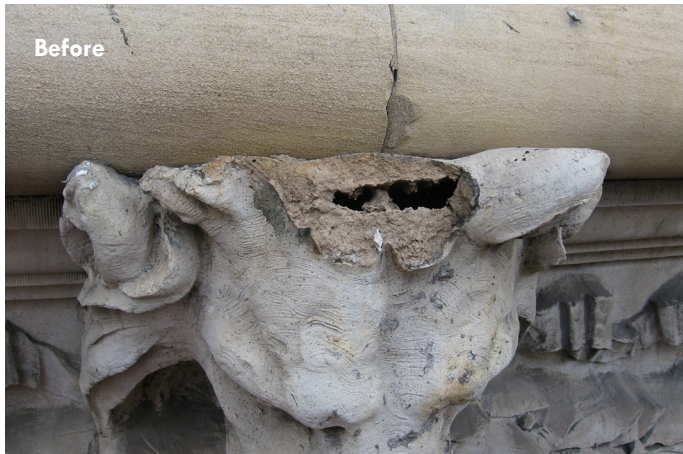
Glazed terra cotta was designed to be cleaned cheaply and easily. Typically, all that is required is water, detergent, and a natural or nylon bristle brush for gentle scrubbing. Strong acid solutions may deteriorate mortar, release salts in the terra cotta, and cause efflorescence, and are best avoided. While generally not necessary, some proprietary commercial solutions may be suitable for use on terra cotta; check manufacturers' recommendations. Avoid abrasive cleaning, such as sandblasting, as well as high-pressure water or metal bristle brushes, all of which can damage glazing irreversibly.

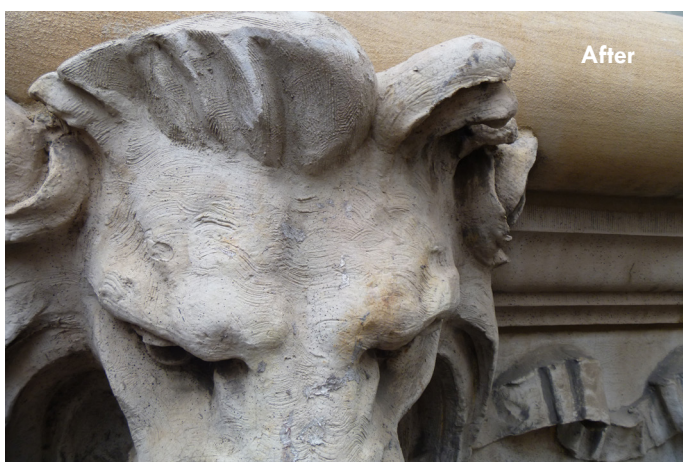
Although persistent water infiltration may make a waterproof coating seem like a good idea, indiscriminate coating of the entire wall is generally inadvisable, as it may trap water and make matters worse. Serious crazing may be treated on a limited scale; however, most glaze crazing does not substantially increase the flow of water into the wall. Unless the source of moisture infiltration is addressed, applying an impervious coating will only serve to prevent outward migration of water from within the assembly.

Maintaining mortar joints is very important to the lifespan of the terra cotta. Periodic repointing prevents water entry and inhibits deterioration. It's important to use a mortar with a compressive strength that is lower than that of the adjacent terra cotta, since a hard mortar may prevent the outward migration of water and may cause point loading. Never repoint with sealant, as it impedes moisture movement. Use sealant selectively, such as at joints in horizontal surfaces of copings and sills.

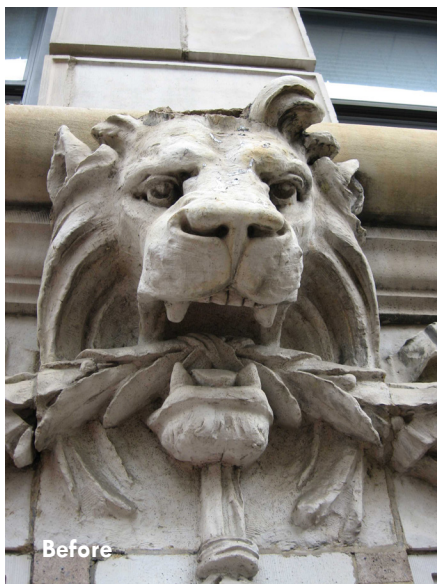
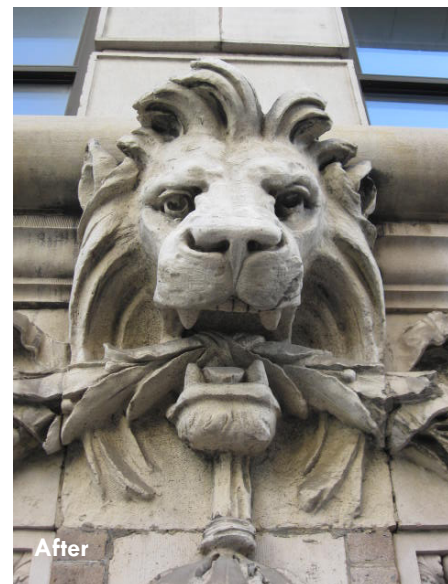
Untreated deterioration can result in hazardous conditions.

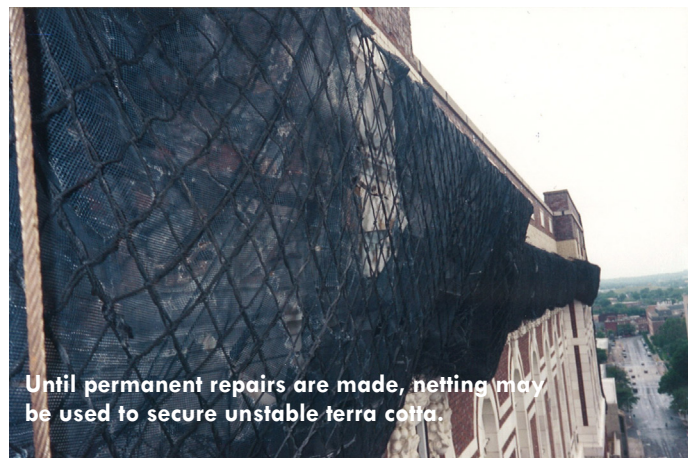
Until permanent repairs are made, netting may be used to secure unstable terra cotta.

Where deterioration is so severe that pieces may fall from the building, temporary stabilization or replacement may be necessary to protect public safety. Particularly in urban areas or locations with high seismic activity, code compliance—and civic responsibility—dictate the immediate securing of identified hazards. Until a permanent solution can be implemented, nylon netting and metal strapping are commonly used to secure unstable pieces.

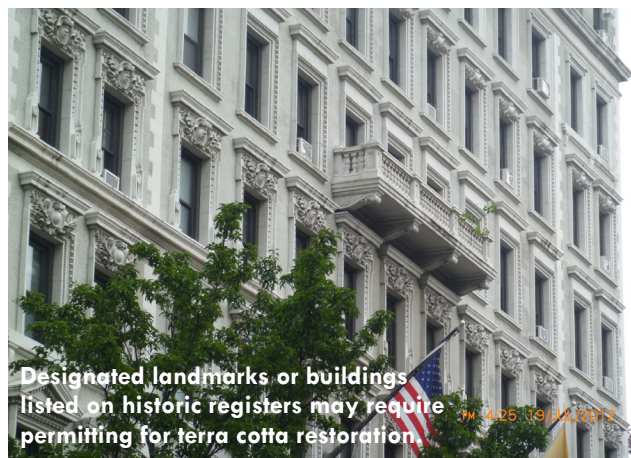
**Stone** is durable and may be the best match for terra cotta that was originally cast and glazed to imitate natural stone. However, it weighs significantly more than terra cotta, and the cost may be just as high, especially where ornately detailed carving is involved.

**Precast concrete** is cost-effective, offers rapid production times, and can usually replicate original detailing. When cast hollow with lightweight aggregate, its weight is comparable to that of terra cotta, and it typically produces good results in color matching. For visual compatibility and waterproofing, a clear masonry coating should be applied to the weather face. On the downside, precast concrete may not be as long-lasting as is terra cotta.

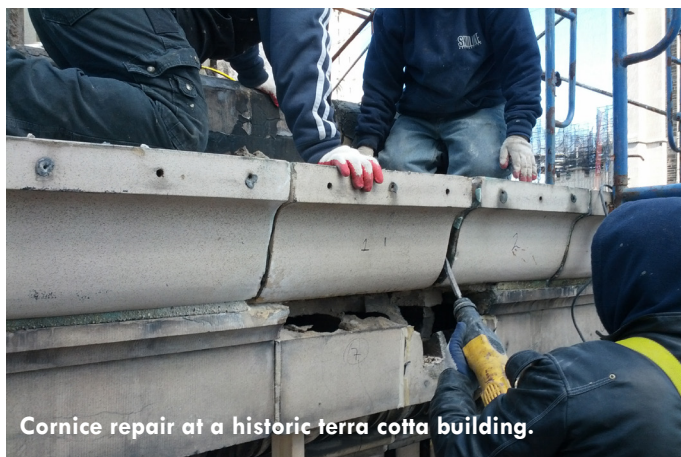
**Micro-cotta**, a polymer-based composite concrete, is a proprietary product developed for terra cotta rehabilitation. Lightweight and capable of reproducing detail with sharp definition, Micro-cotta uses a finer aggregate than does cement-based concrete and has a lower absorption rate. However, there is some evidence that early formulations tended to fade and yellow in sunlight, and may have been susceptible to excessive crazing.

On the whole, substitute materials tend to offer faster manufacture and cost savings over replacement terra cotta. However, even closely matched alternatives may have a slightly different appearance than terra cotta; some are glossier, and concrete products tend to darken when wet. Unlike decorative elements or cladding, structural terra cotta may be difficult to substitute, as an entirely redesigned structural system may then be required.
