HOTEL MONACO
HISTORIC CORNICE
REPAIR

The Hotel Monaco Historic Cornice Repair project was an approximately \$200,000 project completed expeditiously in three months to repair a seven foot long portion of the decorative marble lower cornice which fell from the building suddenly on July 15, 2010. This historic landmark was formerly the original US General Post Office and is located in Washington, DC. The project involved a series of initial investigations, specialized testing of the historic marble and mortar, installation of new hand-carved replacement cornice elements utilizing marble from the original quarry, and other miscellaneous repairs to the marble façade in an effort to arrest detrimental water infiltration. Water migration through cracks in the marble throughout many freeze/thaw cycles was determined to have caused the failure; atmospheric staining was present on over eighty percent of the length of the break. Two horizontal slabs of marble make up the cornice; the lower cornice (10" thick) consists of decorative dentils and rosettes; the upper cornice (8" thick) features a decorative profile. Both

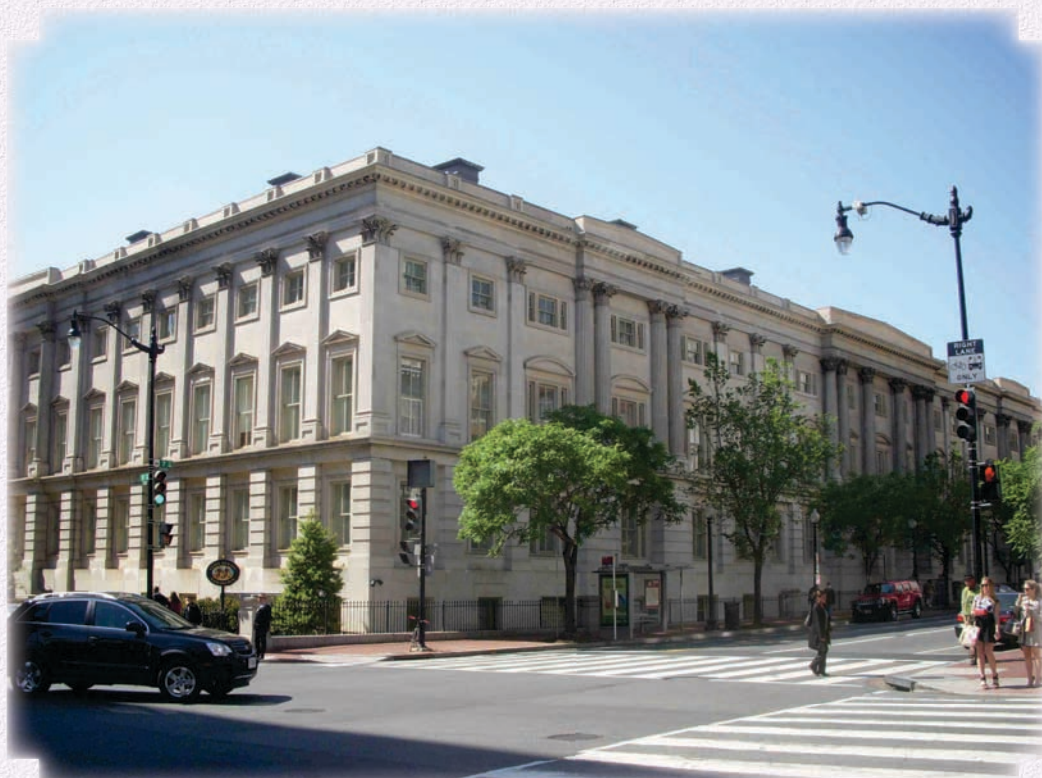
Lower cornice immediately after failure; note water staining along majority of break, as well as along the vertical head joint in the upper cornice above.

On July 15, 2010, an approximately 6'-8" long section of the lower cornice containing five dentils fell suddenly. The marble failed approximately eleven inches back from the face; the remaining surrounding marble was determined to be in sound condition. Initial investigations revealed that the failure was due to water infiltration through cracked and

open mortar joints in the parapet capstone and cornice over multiple freeze/thaw cycles, which caused an interior crack to develop. Atmospheric staining was present along eighty percent of the length of the break, suggesting that the crack had been there for some time prior to the failure. As the crack expanded and separated,

slabs are essentially counter-weighted by a parapet capstone, which had to be carefully removed and reinstalled upon installation of the replacement cornice slabs. In addition to replacing the section of lower cornice which fell, two other slabs that were significantly cracked were proactively replaced.
